34-099-2-3184-00-00

Subject: 20" casing failure

Cement Bond Log
Gamma Ray/CCL/Temp

Company	Consol Energy	Company	Consol Energy
Well	Mahn #7C	Well	Mahn #7C
Field	N/A	Field	N/A
County	Mahoning	County	Mahoning
State	OH	State	OH
Date	13-Oct-2012	Location:	API #: 34-099-2-3184-00-00
Run Number	One	SEC	TWP
Depth Driller	370'		RGE
Depth Logger	343'	Jackson Township	
Bottom Logged Interval	343'	Permanent Datum	Ground Level
Top Log Interval	0	Log Measured From	Ground Level
Open Hole Size	26"	Drilling Measured From	Kelly Bushing
Type Fluid	Water		Elevation 1060'
Density / Viscosity	8.3		Elevation
Max. Recorded Temp.	96		K.B. N/A
Estimated Cement Top	0		D.F. N/A
Time Well Ready	ROA		G.L. 1060'
Time Logger on Bottom	N/A		
Equipment Number	14061		
Location	Weston, WV		
Recorded By	S Farnsworth		
Witnessed By	Wendell Shrewsbury		
		John Fleming	
Run Number	Bit	From	To
		Size	Weight
		From	To
Casing Record	Size	Wd/Ft	Top
Surface String	20"	94	0
Prod. String			
Production String			
Liner			Bottom
			343'

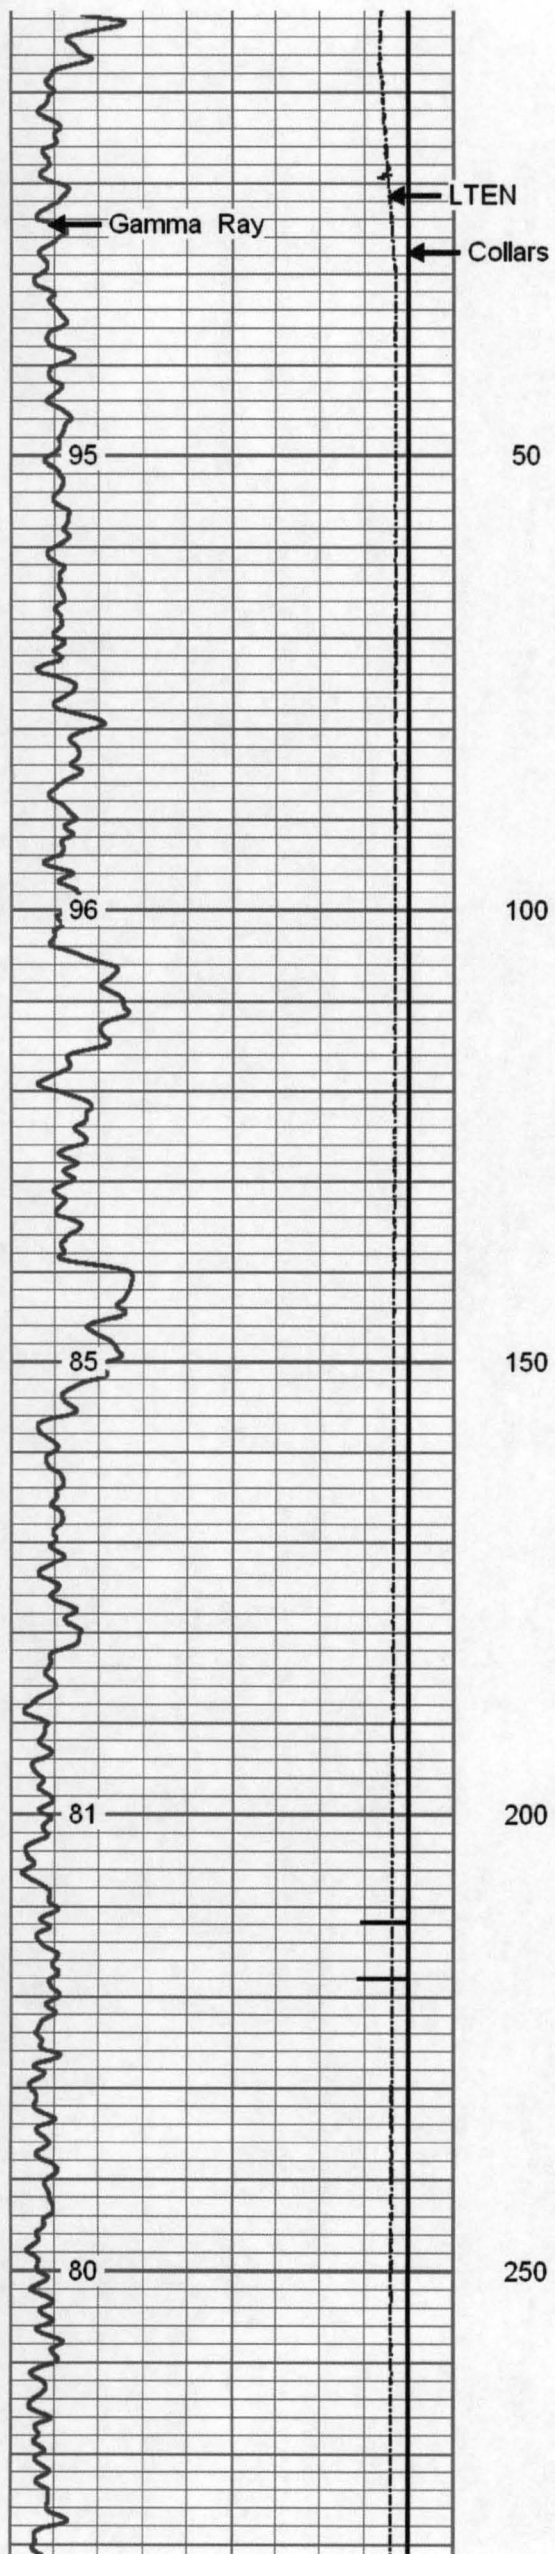
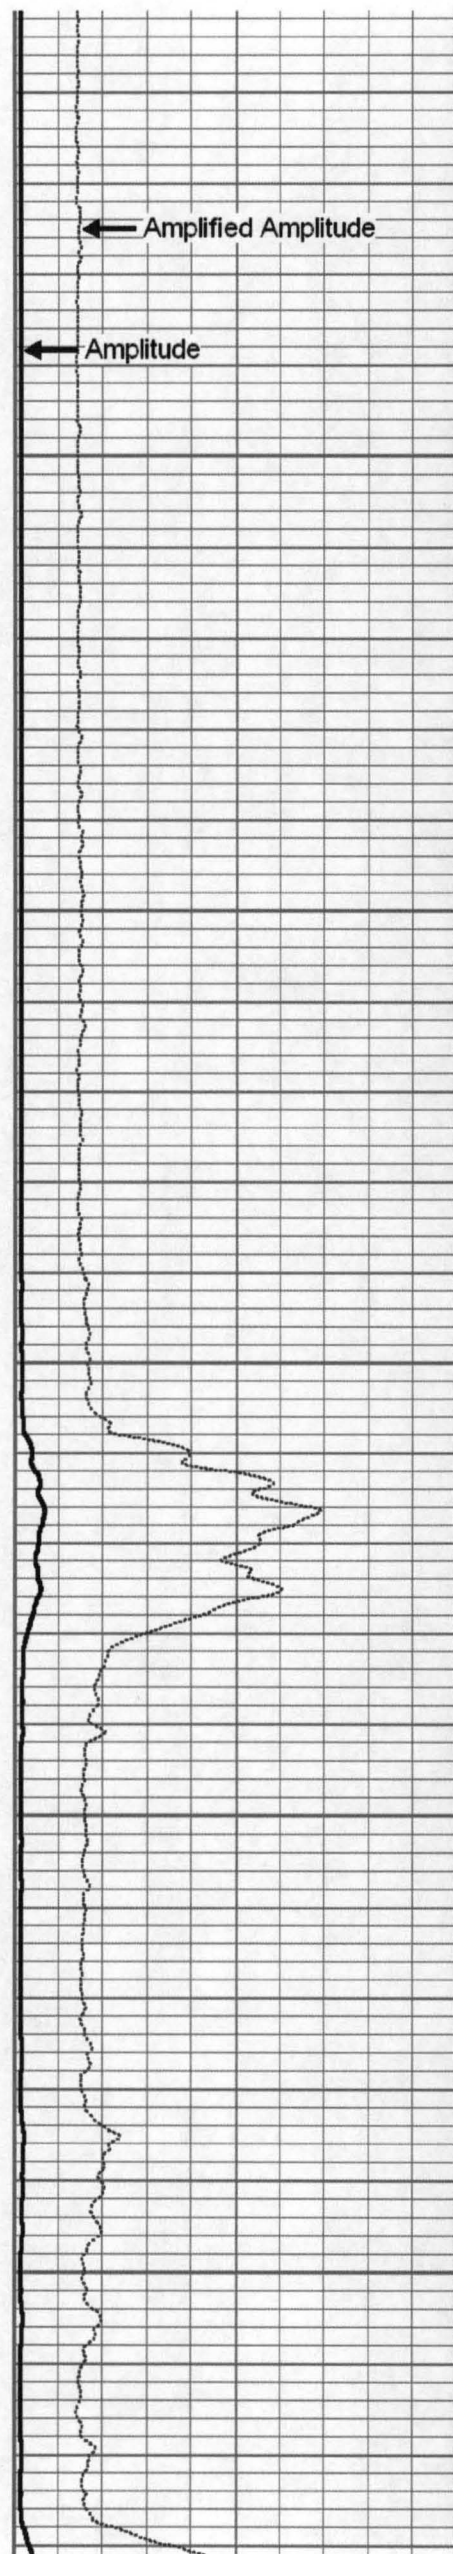
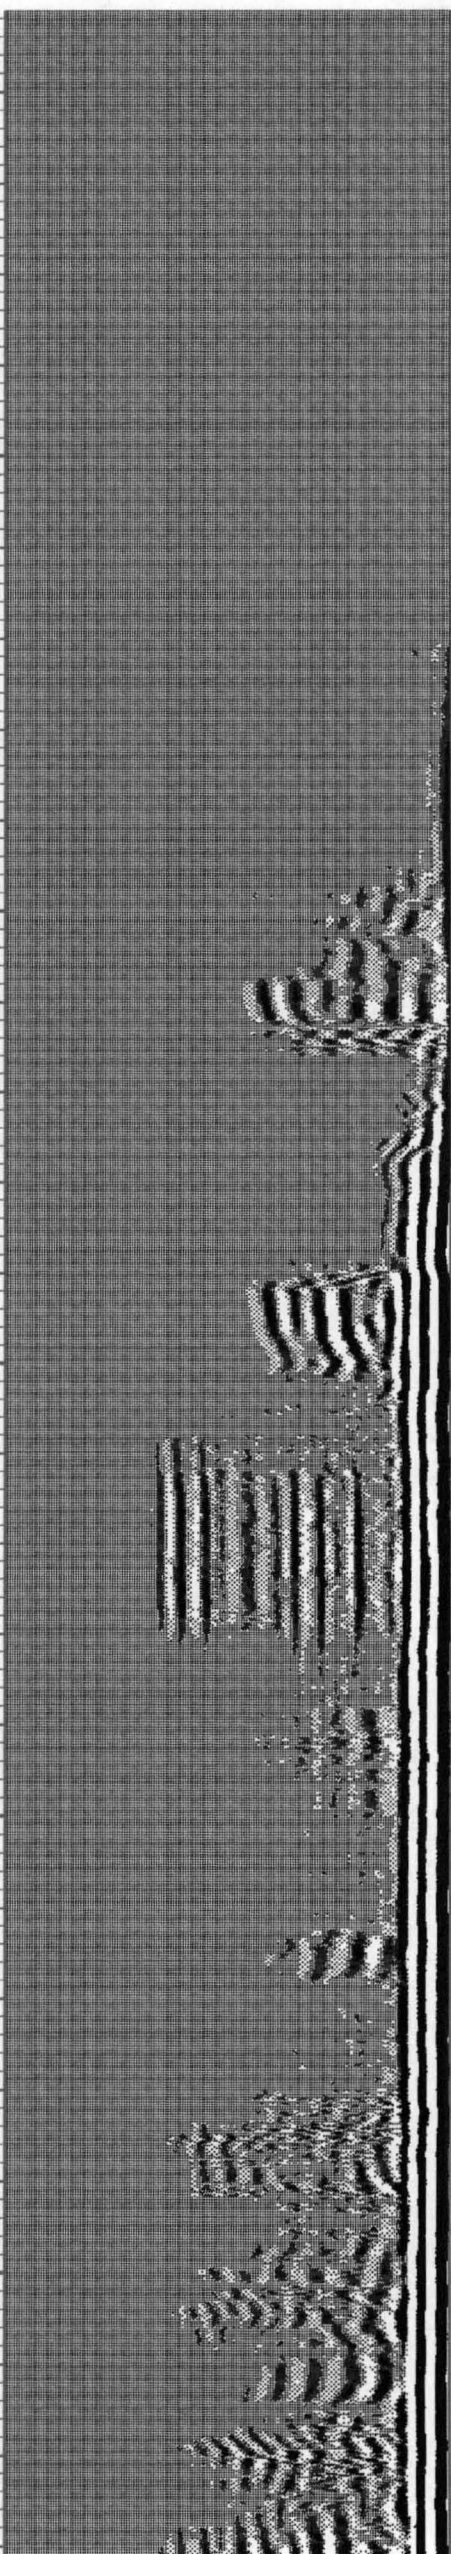
Main Log

We were able to run the CBL tool with no issues we ran two passes again to verify the information and tools we reading properly. The logs look llike there is no cement from 100' above but the wireline operator assured us that was not enough hydrostatic for the tool to read. We can physically confirm we have cement all the way to surface. The bond shows cement throughout the whole string and a good bond. The surprising information found from this logging run is the GR and Temp log. First the GR shows one hot zone from ~100' to ~150'. I can't see why we would see a GR increase here this all is sandstone from our drilling samples. The most surprising of all is the Temp log. At 200' we have 81 deg, at 150' we have 85 deg, at 100' we have 96 deg, and at 50' we have 95 deg. I have no idea what that temperature difference could be from. Overall in my opinion I believe we have a good cement job and bond on the backside of the casing.
