January 30, 2017

Subject: Contract No. G-102, Amendment to March 26, 2014 Engineering Services Agreement
Dam & Spillway Improvements Project
**PO No. 2016000317: Opinion on Structural Issues Associated with the Dam and
Buildings Task - Letter Report Deliverable**
GF Project No. 58721

Gannett Fleming is pleased to submit this Letter Report providing Mahoning Valley Sanitary District (District) with an opinion on structural issues associated with Mineral Ridge Dam and water treatment-related buildings at the District's Meander Reservoir / Ohltown-McDonald Road campus location. This deliverable has been prepared in accordance with the requirements of the referenced Purchase Order and Gannett Fleming's proposal dated October 18, 2016, and in accordance with discussions during our January 19, 2017 Webex teleconference.

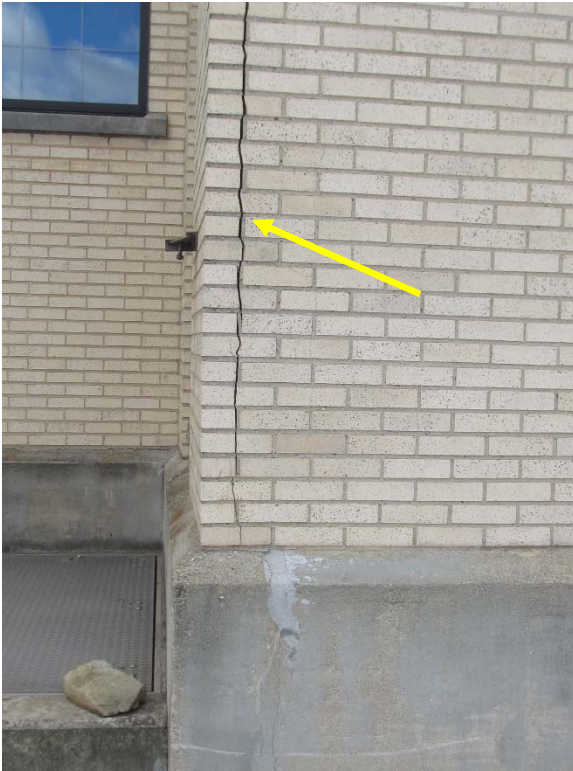
Building 4: Photo 1

- The low roof portion of this building is comprised of masonry bearing walls with steel trusses, and the high roof portion, over the pump room, is comprised of non-bearing walls with steel columns and trusses.
- A vertical crack was observed in the brick exterior at a corner running from the top of the concrete portion to the roof at three locations on this building. See attached Photos 1 & 2.

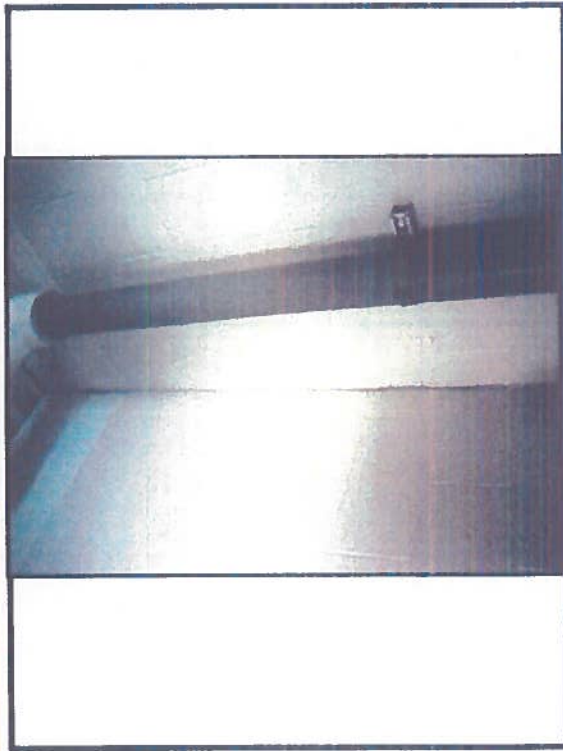
1

Interior Wall Cracking

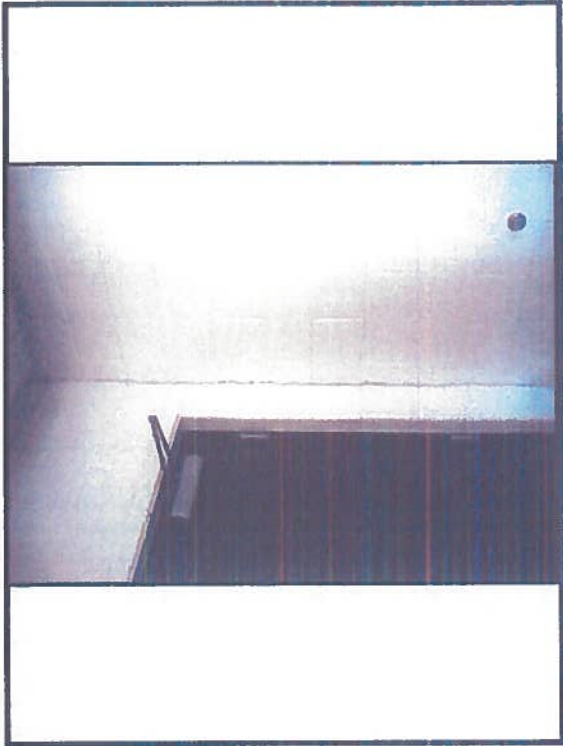
2

Interior Wall Cracking

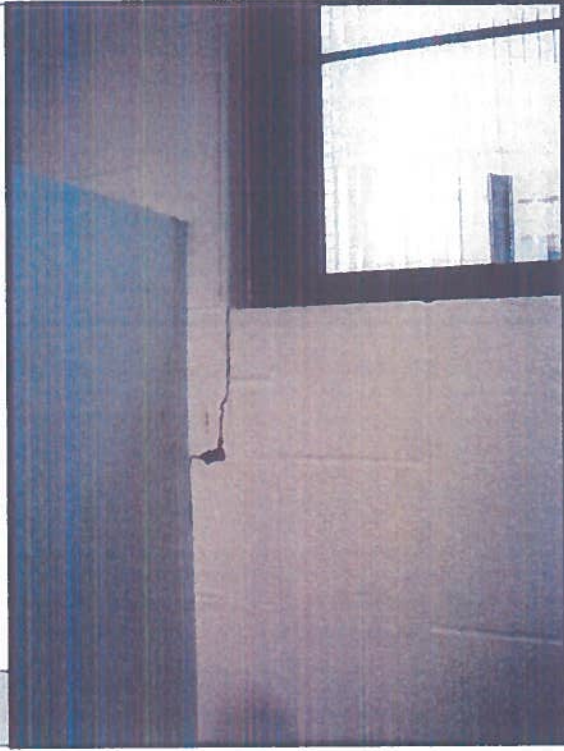
3

Exterior Wall Cracking

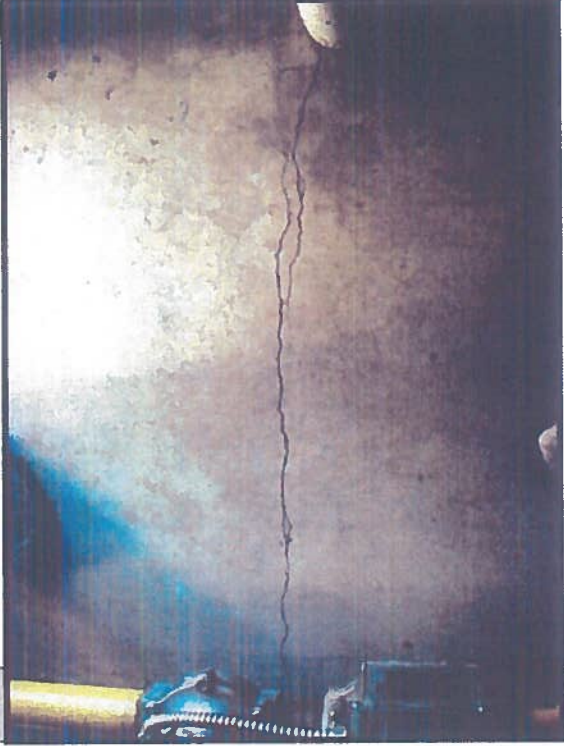
4

Floor Slab Cracking
