January 30, 2017

Subject: Contract No. G-102, Amendment to March 26, 2014 Engineering Services Agreement
Dam & Spillway Improvements Project
**PO No. 2016000317: Opinion on Structural Issues Associated with the Dam and
Buildings Task - Letter Report Deliverable**
GF Project No. 58721

Gannett Fleming is pleased to submit this Letter Report providing Mahoning Valley Sanitary District (District) with an opinion on structural issues associated with Mineral Ridge Dam and water treatment-related buildings at the District's Meander Reservoir / Ohltown-McDonald Road campus location. This deliverable has been prepared in accordance with the requirements of the referenced Purchase Order and Gannett Fleming's proposal dated October 18, 2016, and in accordance with discussions during our January 19, 2017 Webex teleconference.

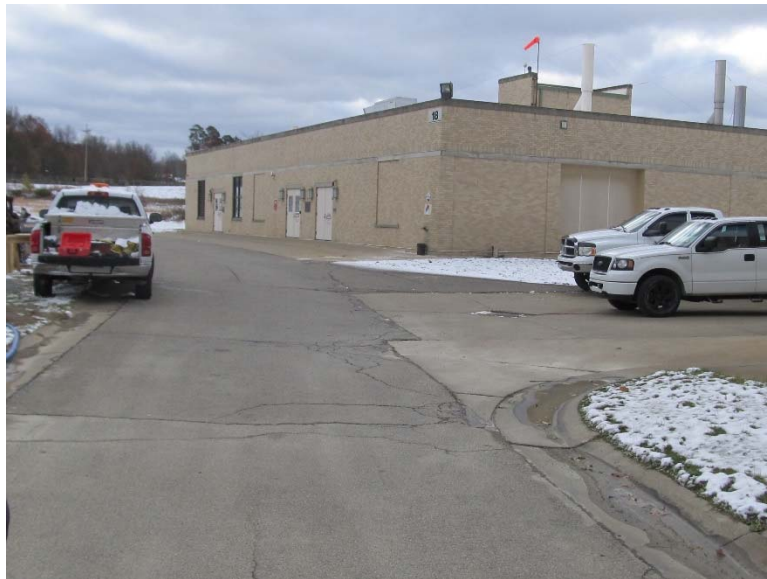
Building 18: Photo 12

- This building was built in the 1990s and has a brick exterior.
- No cracks were observed. See attached Photo 12.

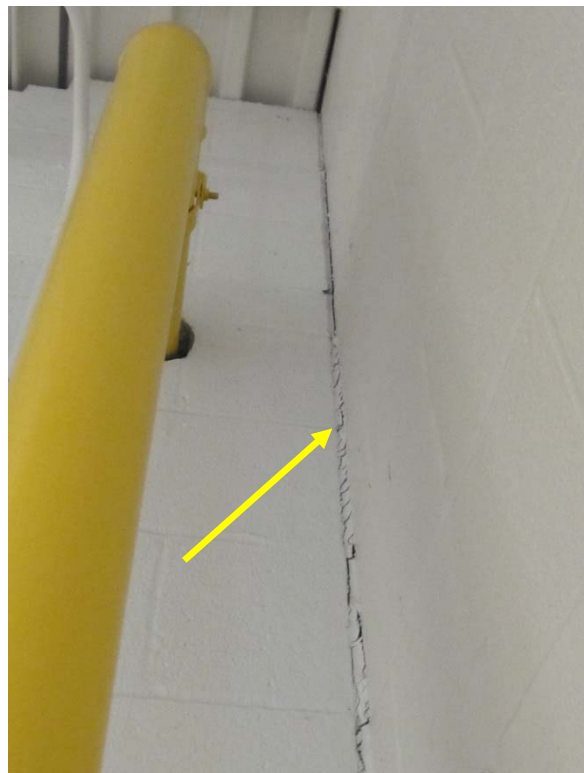
Building 19 2005 Addition: Photo 22

- In the boiler room area, some sealant is separated at the corner CMU joints, and evidence of differential vertical movement is visible between the exterior and interior wall. The exterior masonry wall is supported on a strip footing, but the interior masonry wall is supported on a thickened slab on grade. See attached Photo 22.

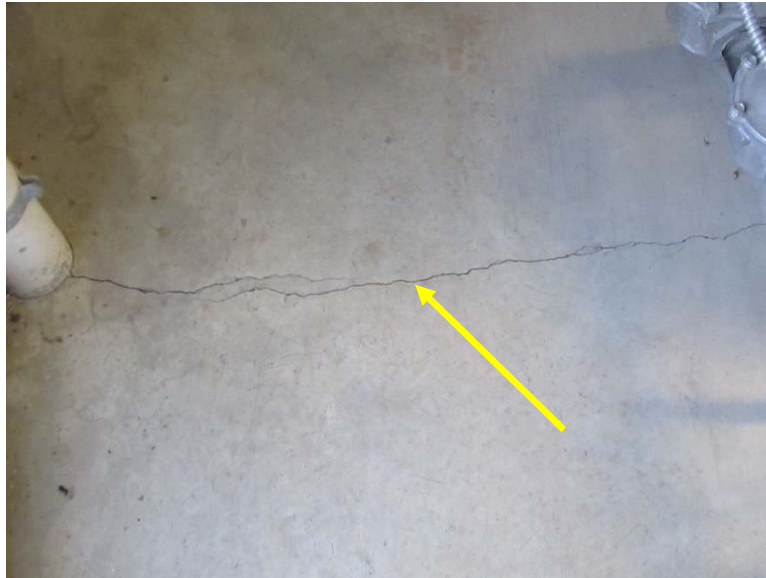
Building 19 2005 Addition: Photo 24

- In the electrical room there are cracks in the corner joints (similar to the boiler room) and no sealant is present to cover the mortar.
- The generator room has a shrinkage crack in the floor. See attached Photo 24. The corner joints have no sealant and the mortar is cracked due to differential settlement between exterior and interior wall as noted in the previous rooms.

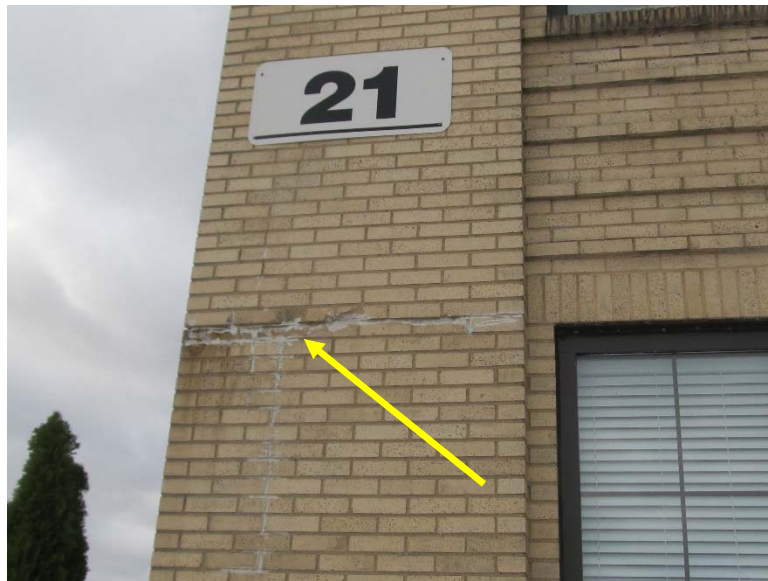
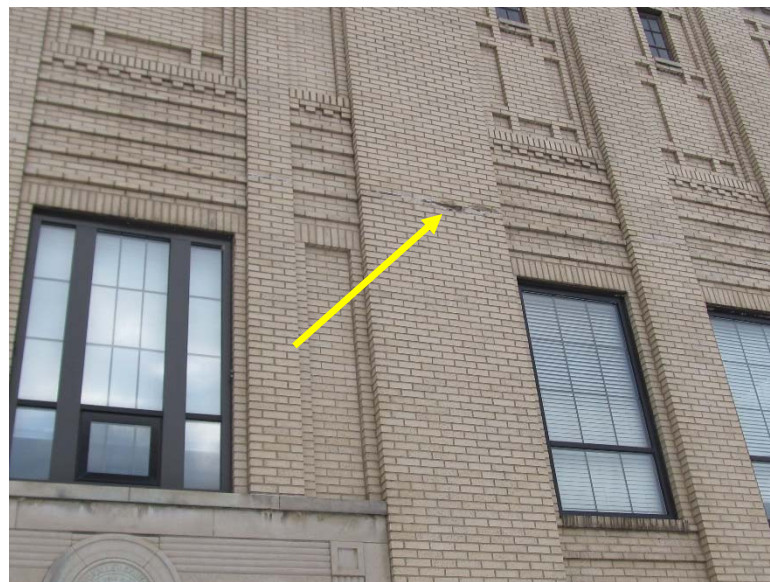
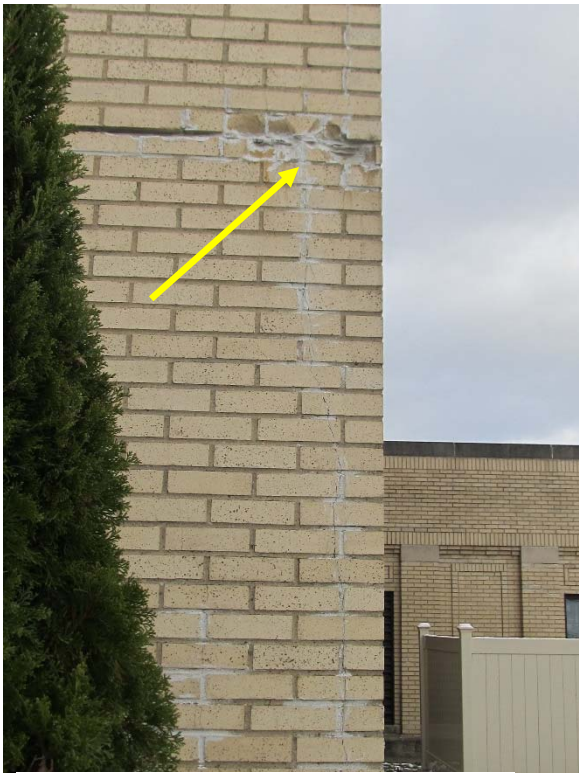
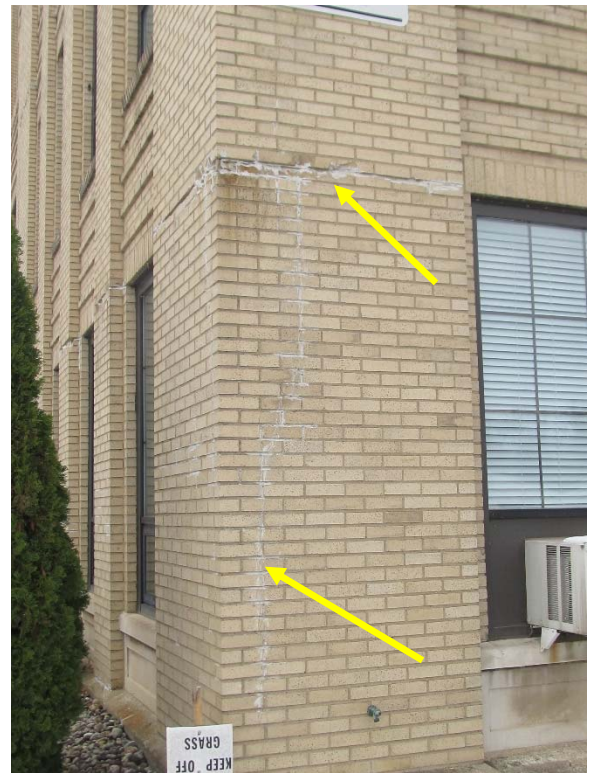
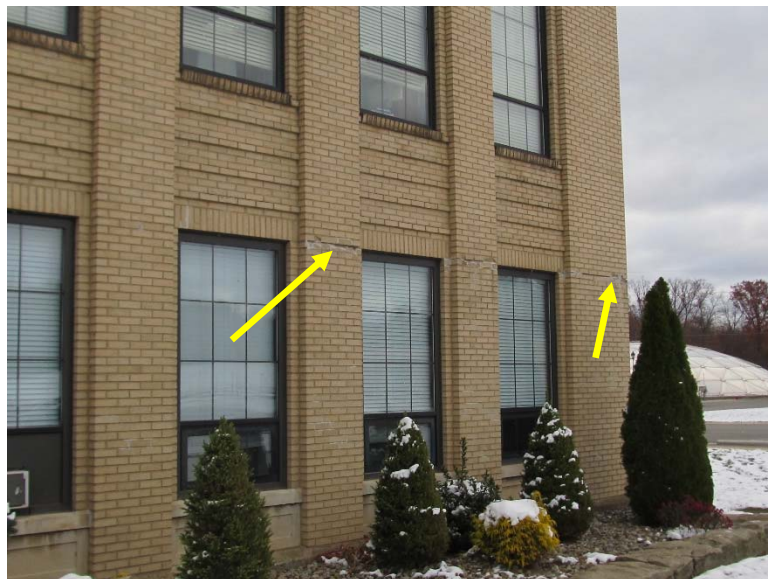
- The building has steel beams encased in concrete and steel columns. The floor beams and roof trusses bear on brick masonry walls.
- There are numerous cracks on the south side of the building and at the southeast corner. Many of the cracks were previously repaired. Typically, there were more defects visible near the bottom of the wall than at the top. See attached Photos 26, 27, 28, 29 & 30.

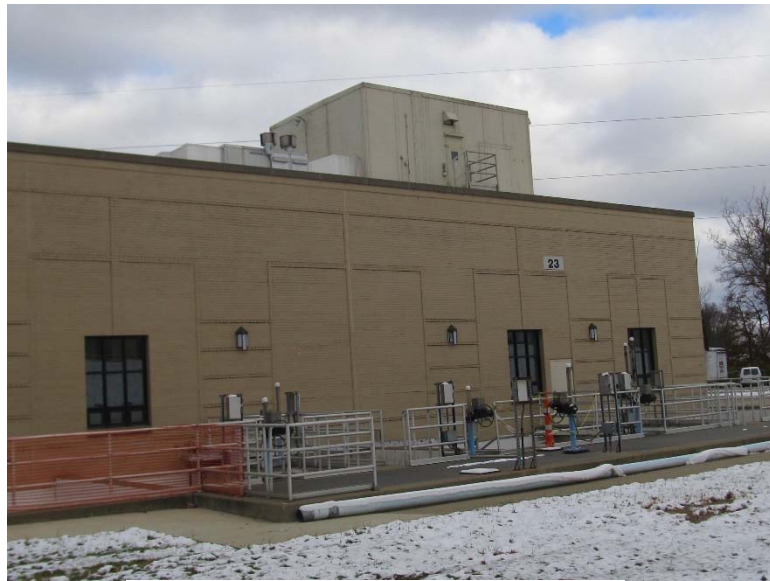
Building 23: Photo 31

- This building was built in the 1990s. The exterior walls are CMU with a brick exterior.
- The exterior brick is in good condition. See attached Photo 31. There is movement at the corner of the building and the retaining wall. The expansion joint between the building and retaining wall has opened up in the corner. The retaining wall is shifting, causing a crack to develop in the concrete portion of the pumping station. This is most likely a result of a dowel that is placed between the retaining wall and the pump station. See attached Photos 32 & 33. There is some interior paint that is peeling away from the concrete walls, which does not appear to be structural-related. See attached Photo 34.

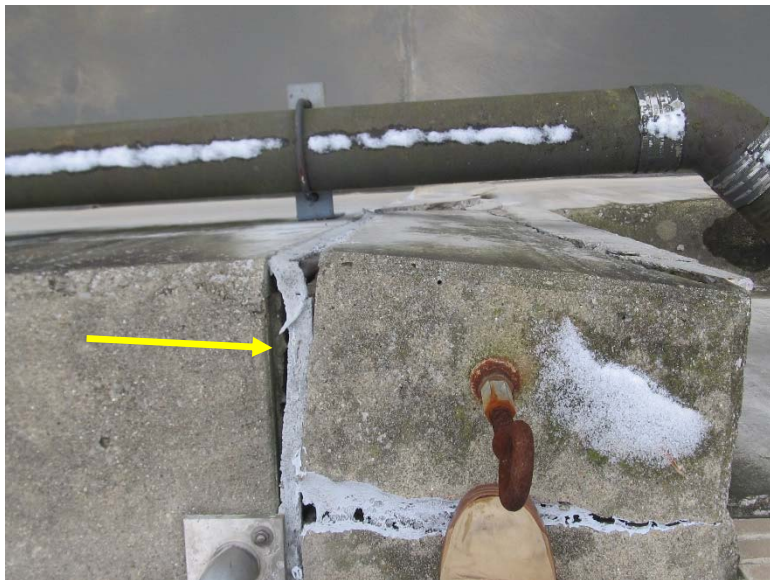
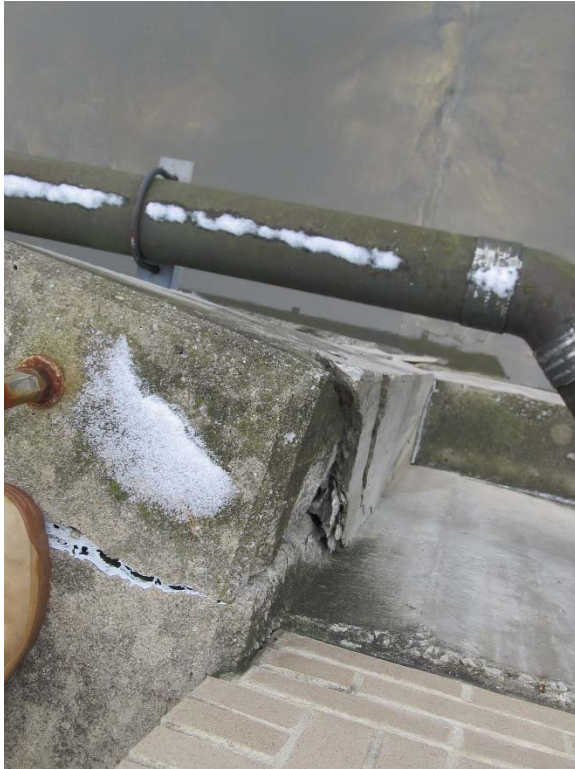
3. Building 23 – Drain Water Pump Station, at the corner where the expansion joint between the building and retaining wall has opened (see attached Photos 32 & 33).

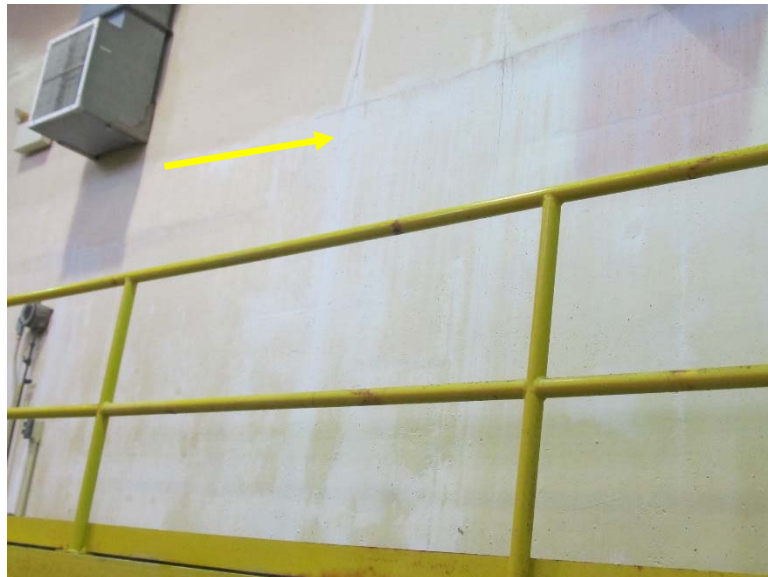
Building 25: Photo 35

- This building has a brick exterior and was built in the 1990s. The roof is supported by steel beams and girders which rest on concrete walls.
- There are a few minor interior cracks visible in the concrete walls, which appear to be due to shrinkage and are not signs of structural deficiency. See attached Photo 35. In the lower level of the building, water is leaking in through an existing conduit communication cable into a conduit box. See attached Photo 36.

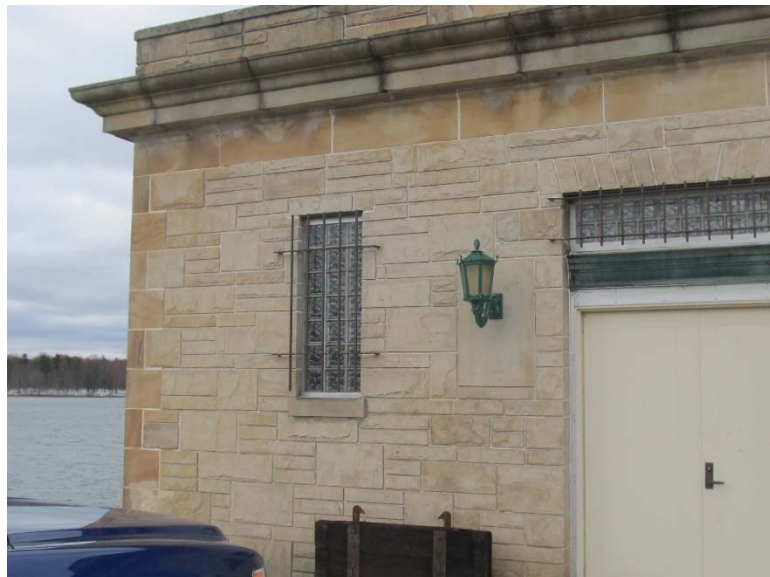
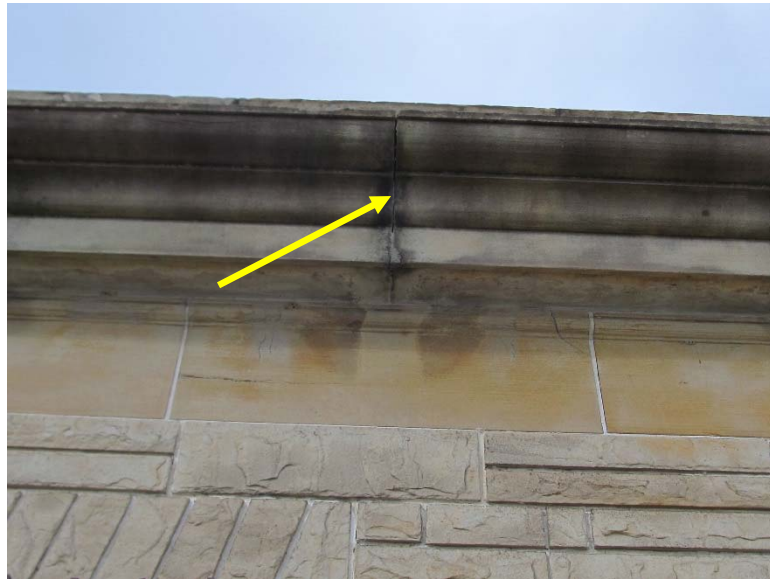
- This building has a brick interior and a stone exterior.
- A repointing project was completed in 1995. In general, it appears that the overall condition of the building exterior is not significantly changed from the conditions that were documented in the Field Investigation Summary Report dated October 2014 and prepared by Gannett Fleming. See attached Photos 37 & 38.

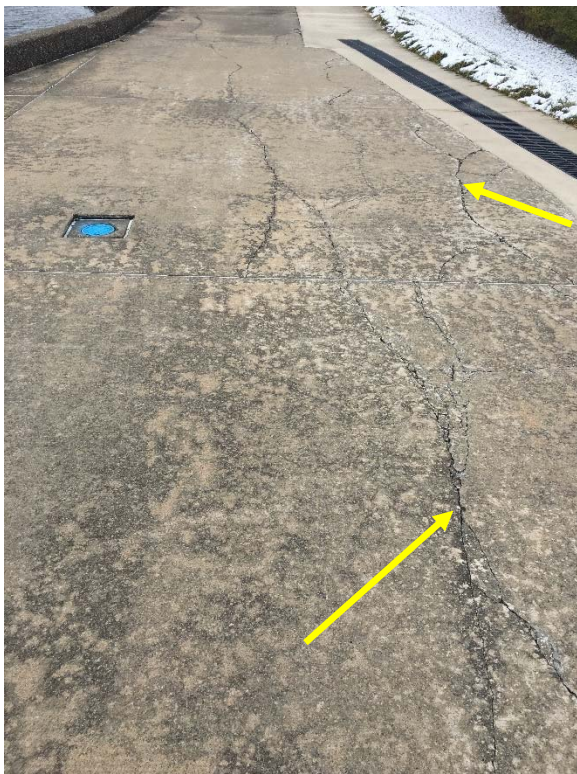
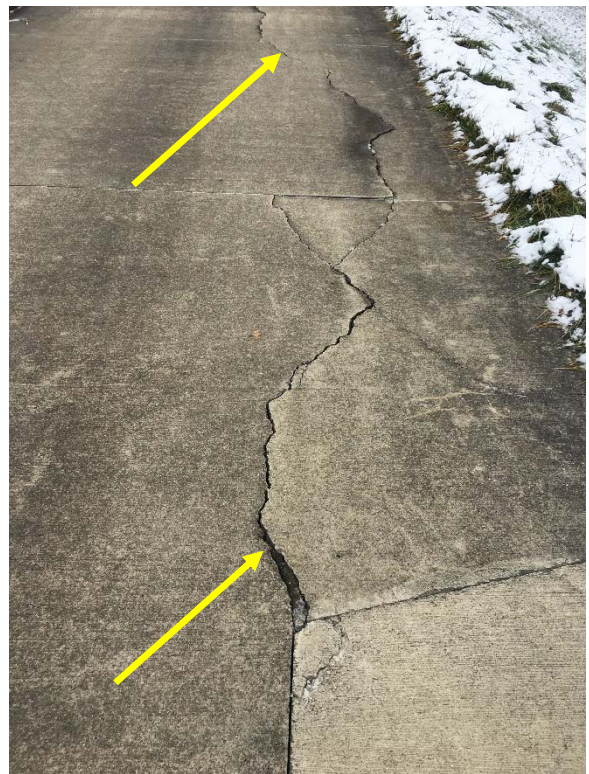
- This is a concrete slab on grade, which is unreinforced except at the emergency spillway crest locations.
- A large crack typically runs down approximately the center of the slab with other cracks present in many locations. See attached Photos 39 & 40.

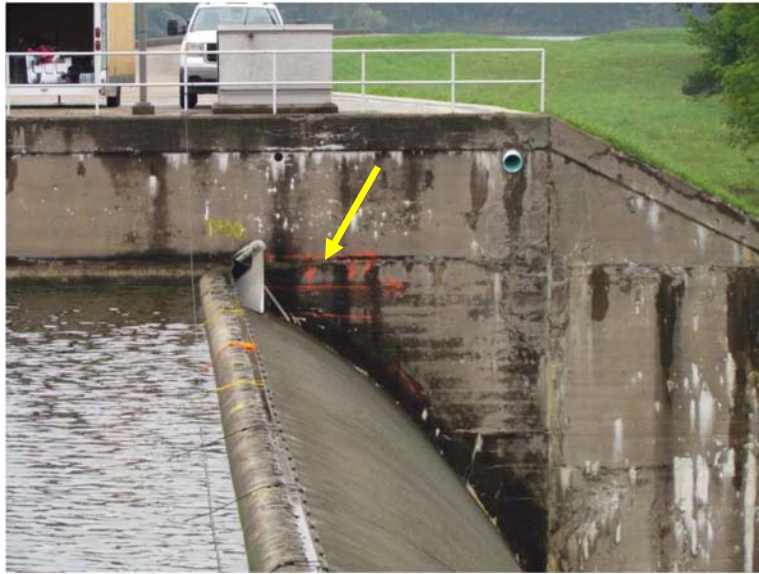
Dam Spillway West Training Wall: Photo 41

- Access to the interior of the inspection manhole was not available to inspect for cracking or to observe the horizontal control joints in the concrete that extend from the face of the principal spillway west training wall near the crest to the interior of the inspection manhole. See attached Photos 41 & 42, which are file photos from a 2014 field inspection.

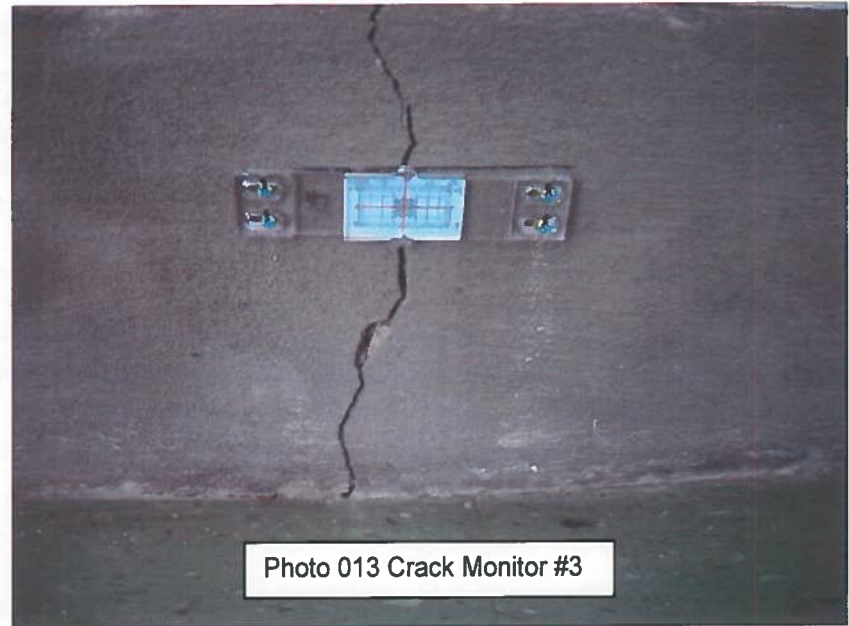
Photo 013 Crack Monitor #3

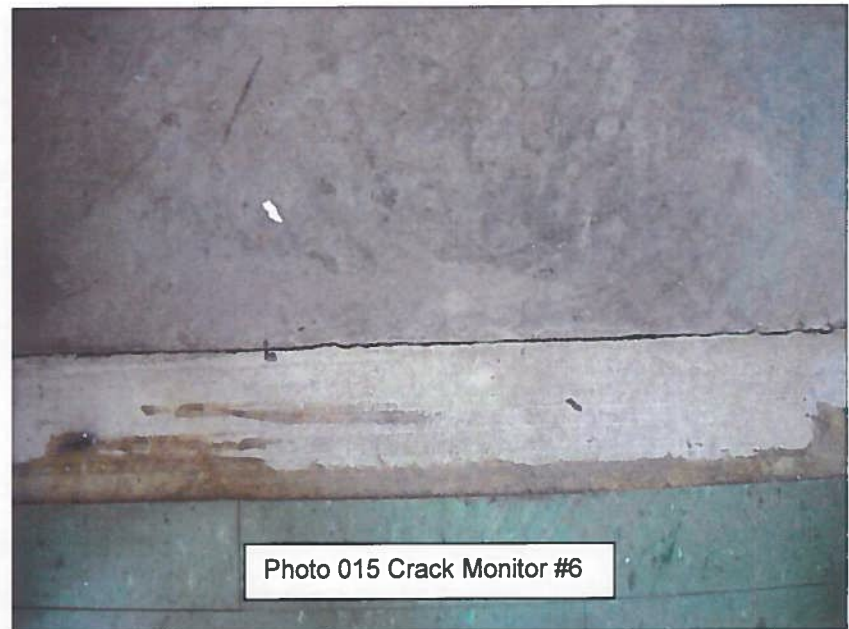
Photo 015 Crack Monitor #6

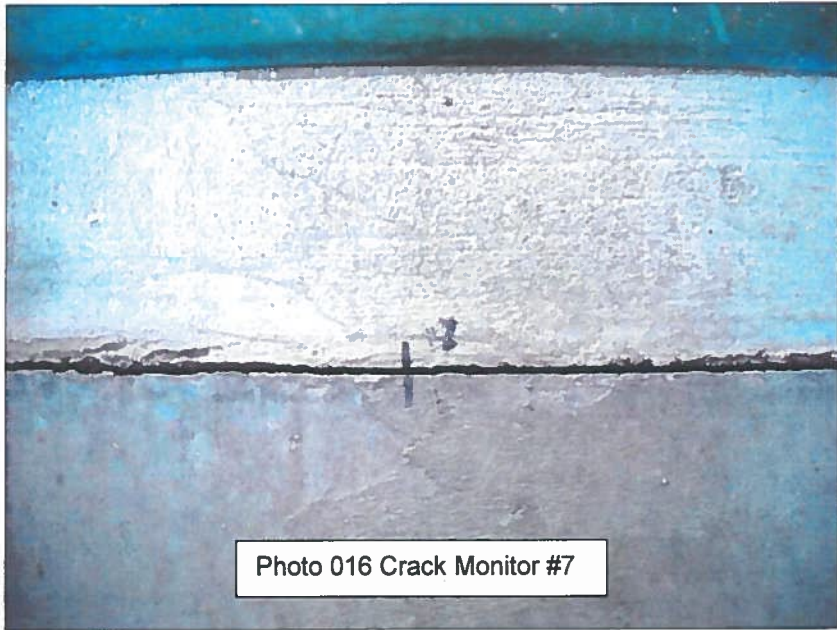
Photo 016 Crack Monitor #7
